Preliminary tests for the development of a beam conditions monitor

Alick Macpherson
PSI/CERN/Auckland

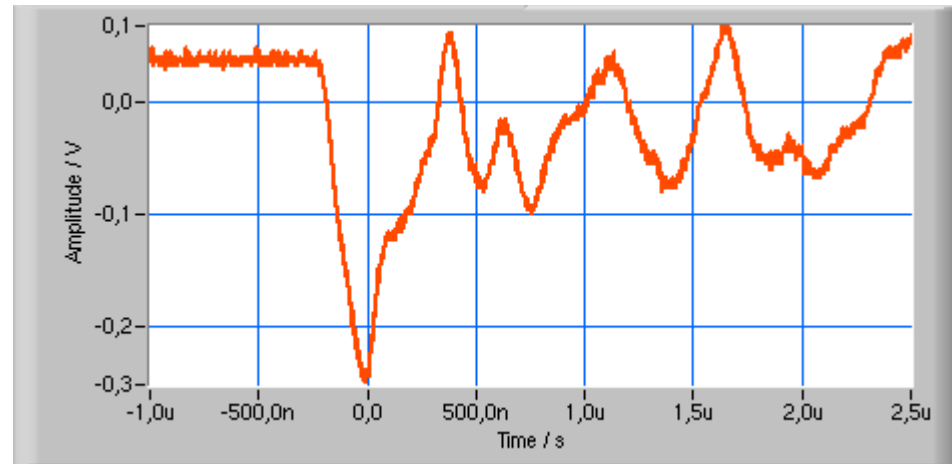
HPK OB2 sensor

HV breakdown with fast recovery plus add. oscillations

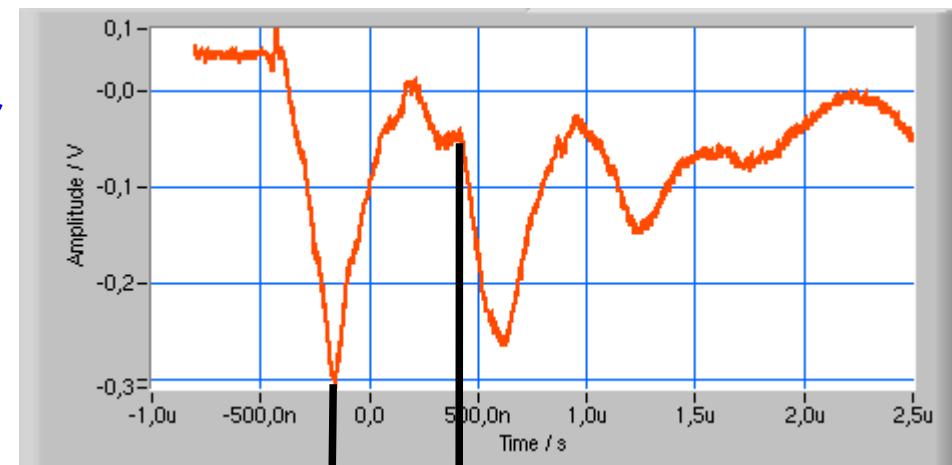
ST W6A sensor

Double HV breakdown

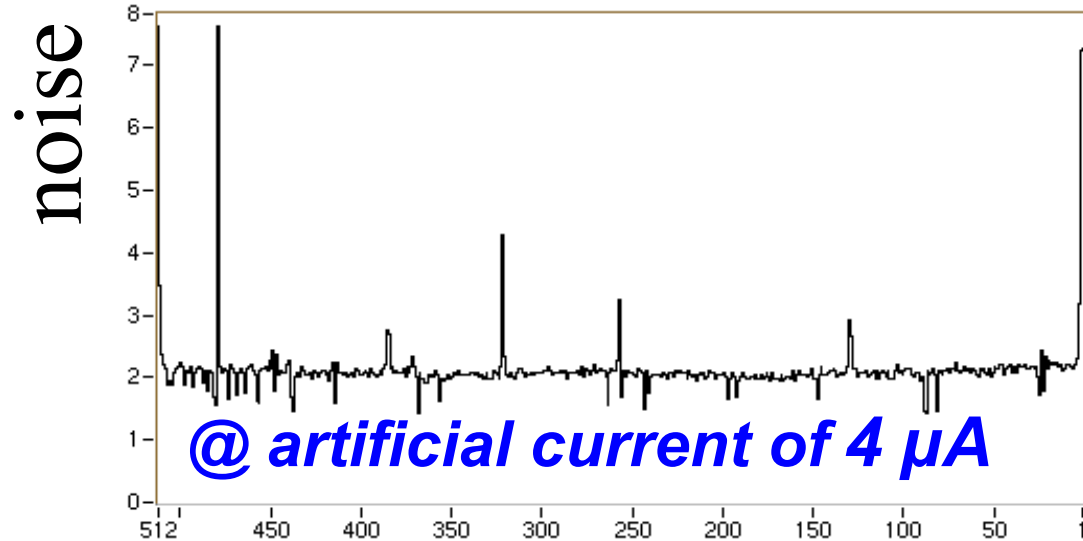
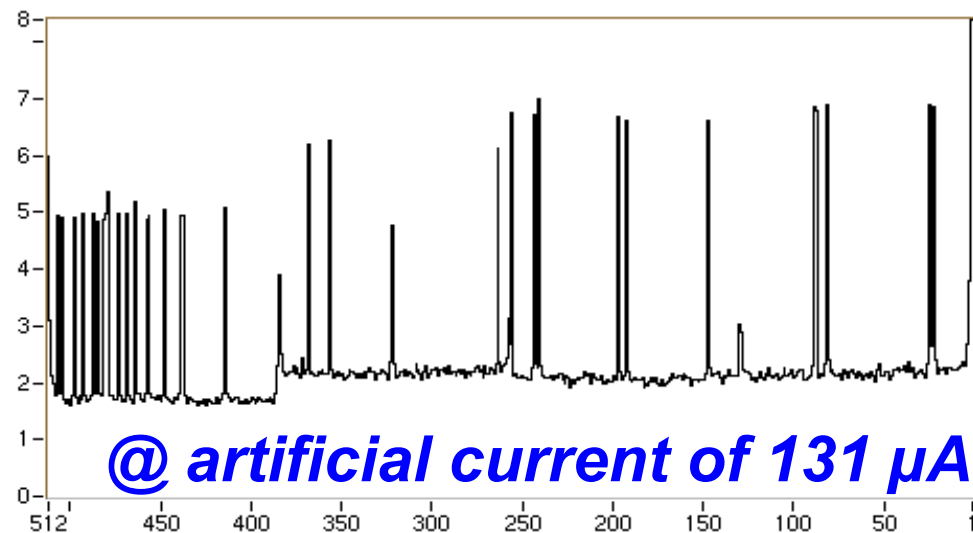
CMS TOB Module

32 pinholes after one shot with $V_{bias} = 400$ V!

Before: 7 bad channels
X5: only some noisy & dead channels

‘Old’ TOB module with M200 sensors from ST used, ***WITHOUT*** the add. SiNitrates in the dielectric (old pinhole problem).

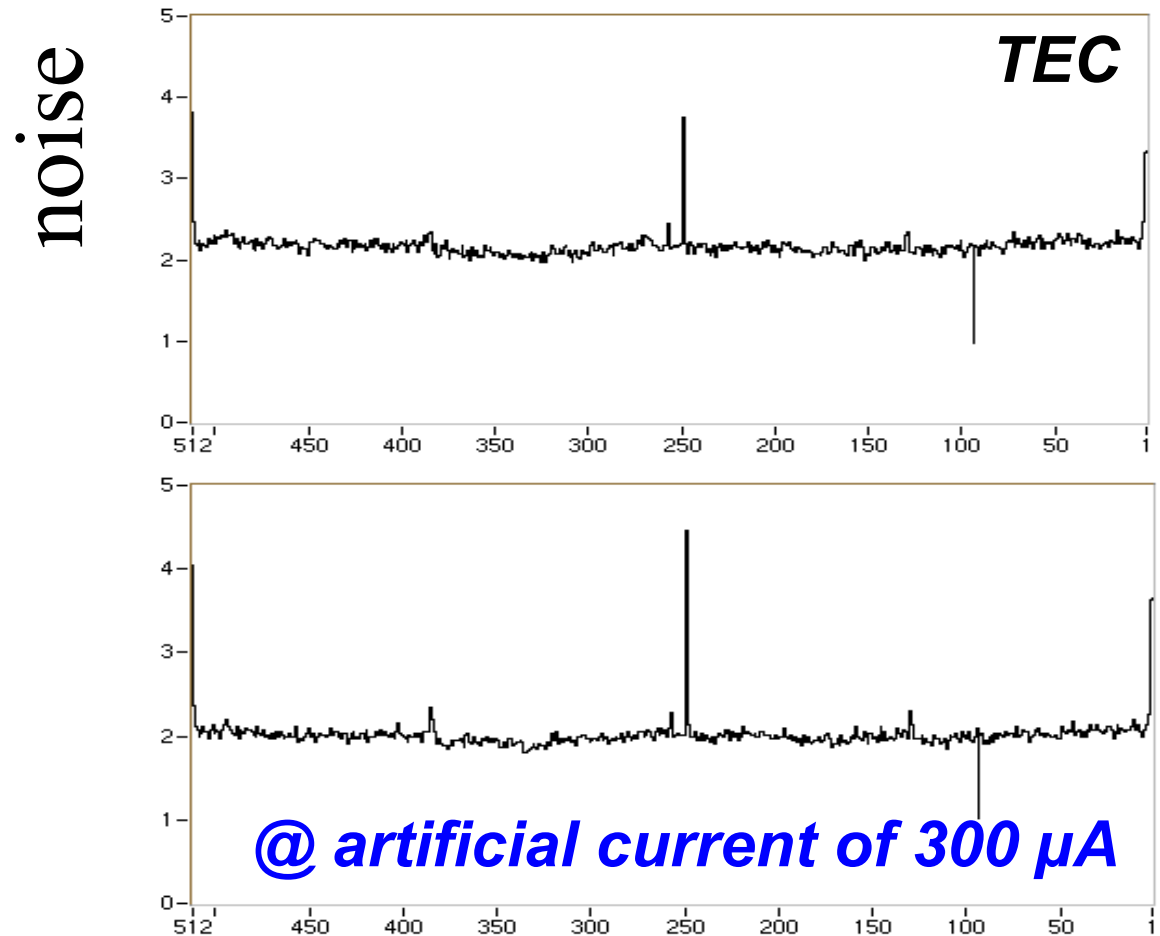
CMS TEC Module

TEC production module:
works fine after a total of 9
“beam dumps”
(including 5 shots @ 500V)

Also no problems with:
Pedestals & Calibration
